CONSTRUCTION REPORT

Project: River Center Branch Library

Project No.: 11-025

Report No.: 034

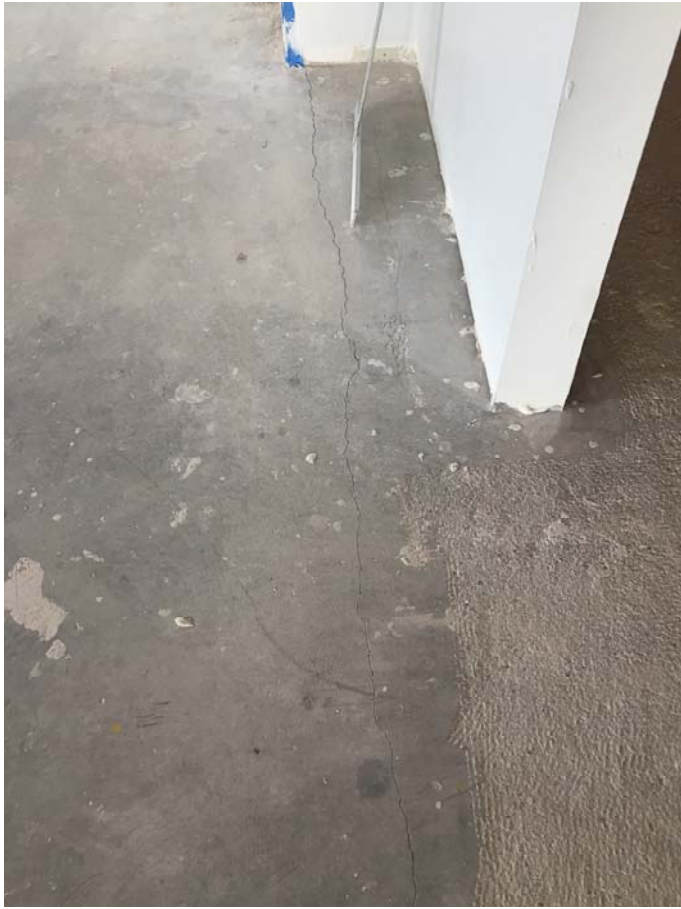
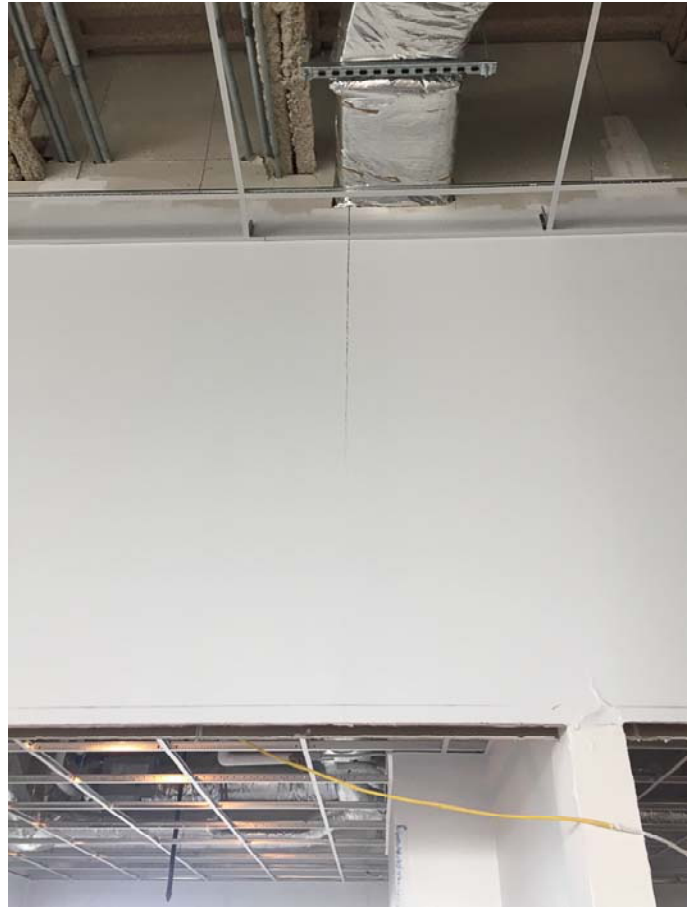
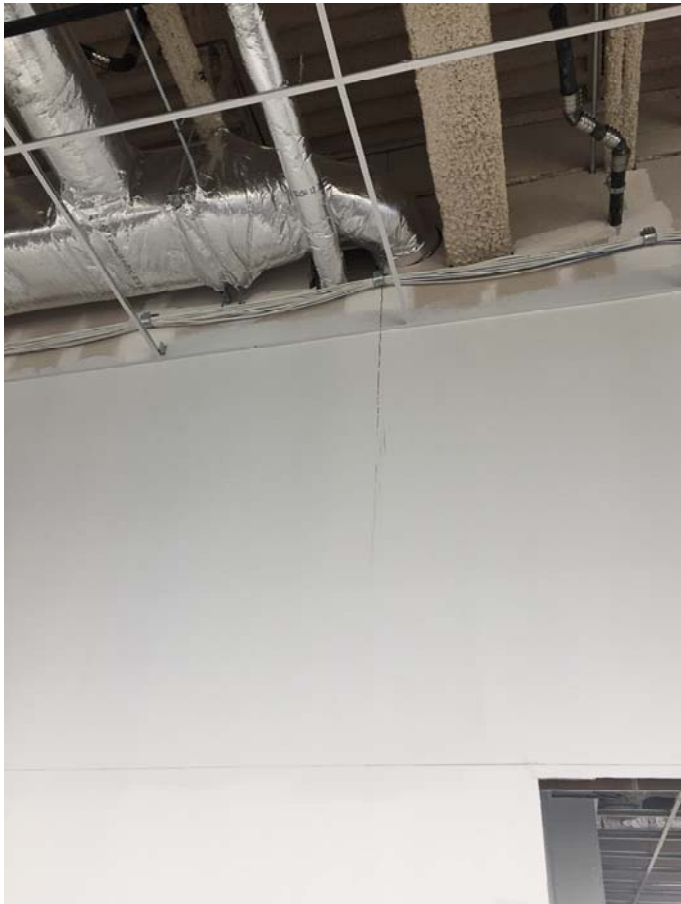
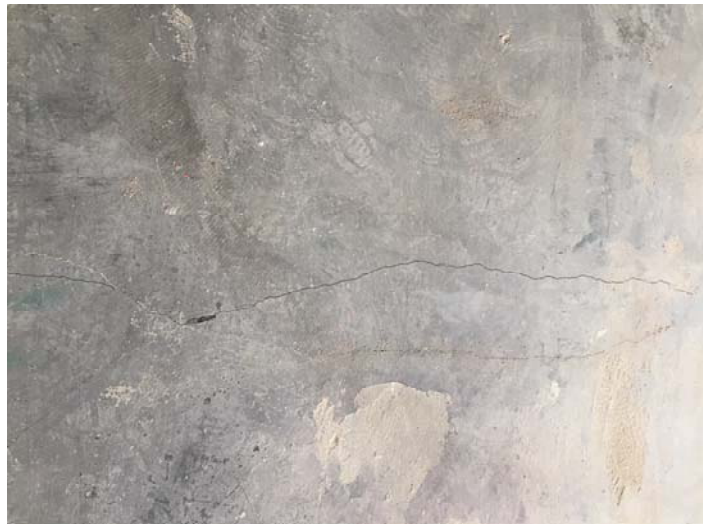
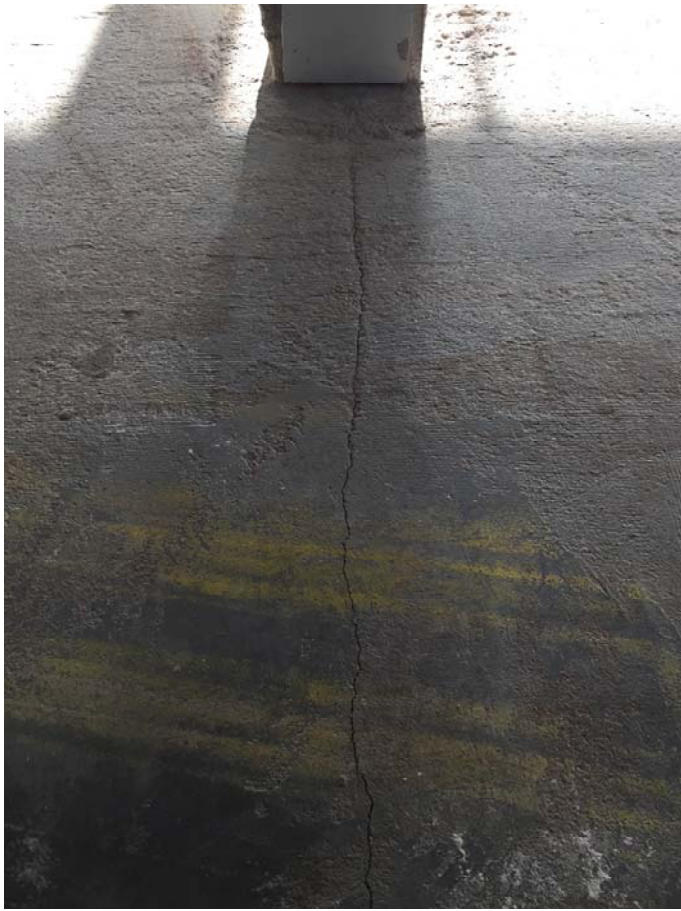
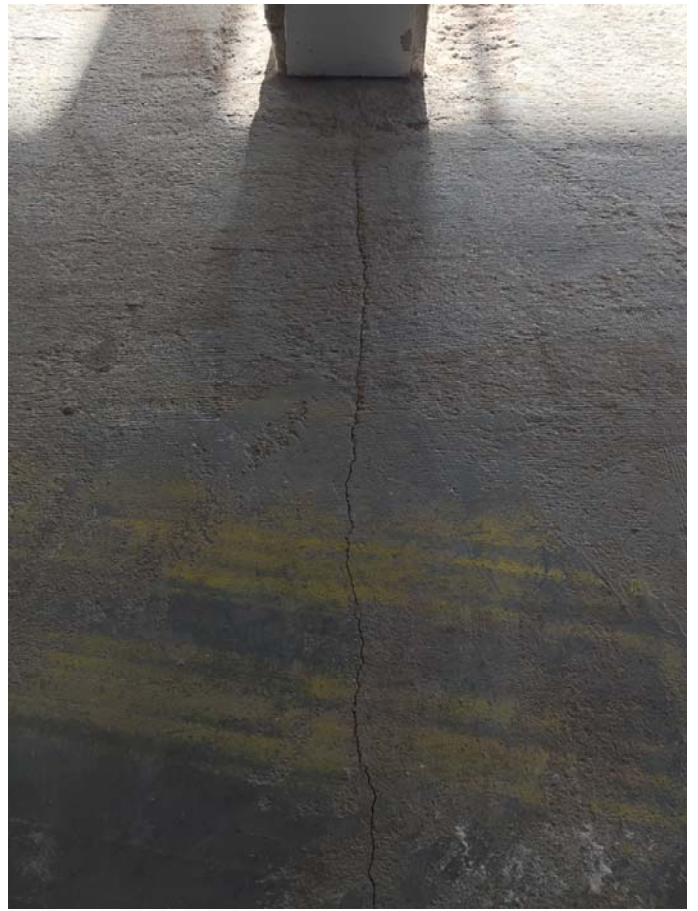
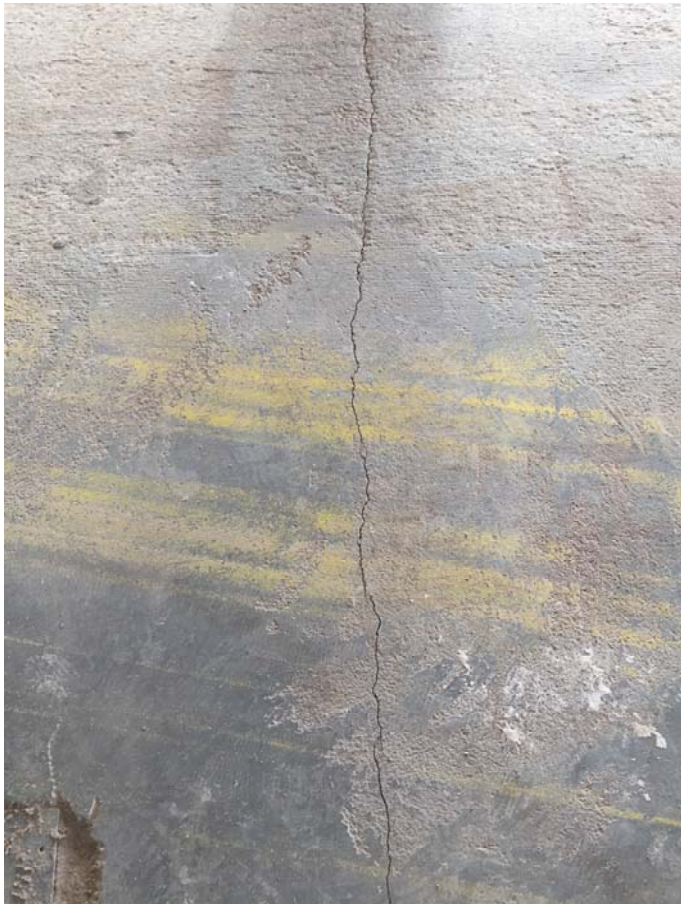
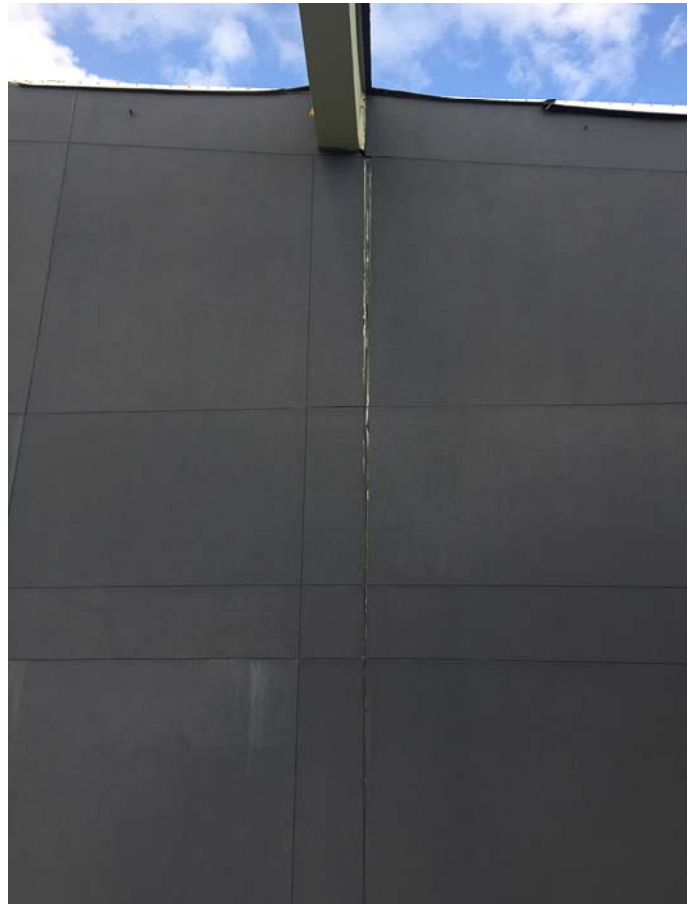
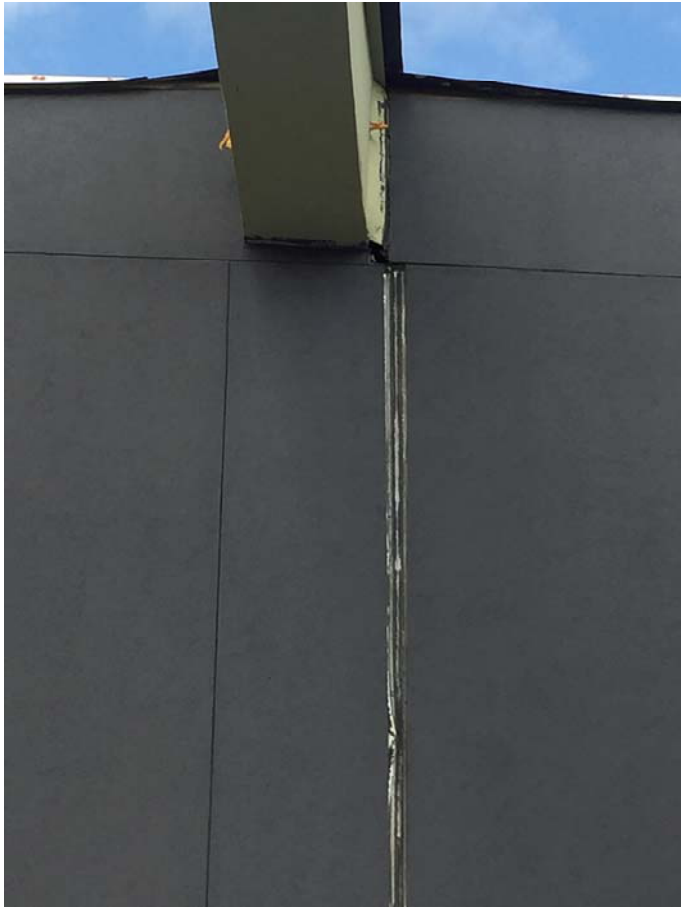
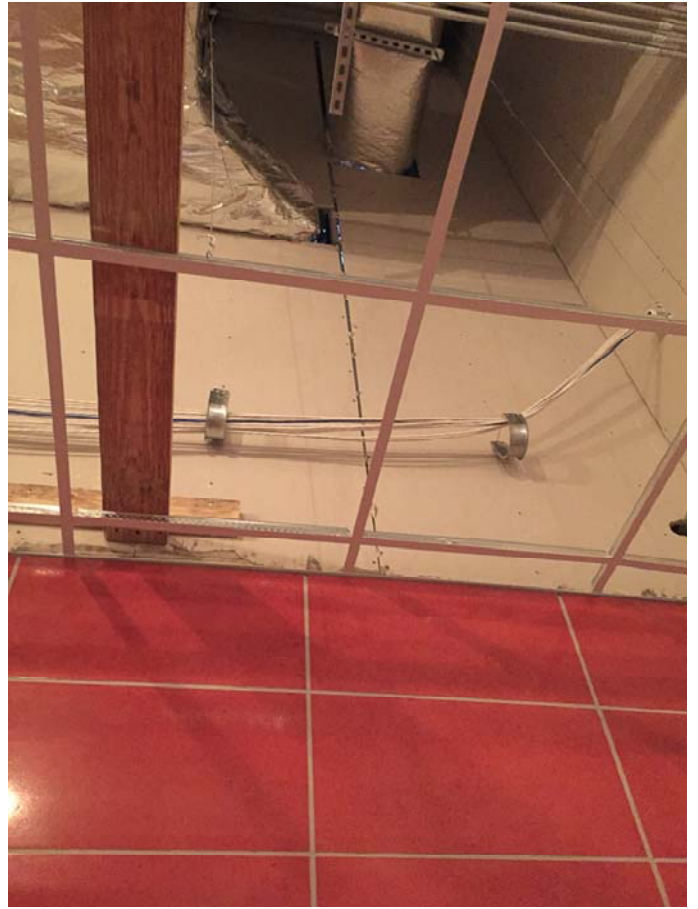
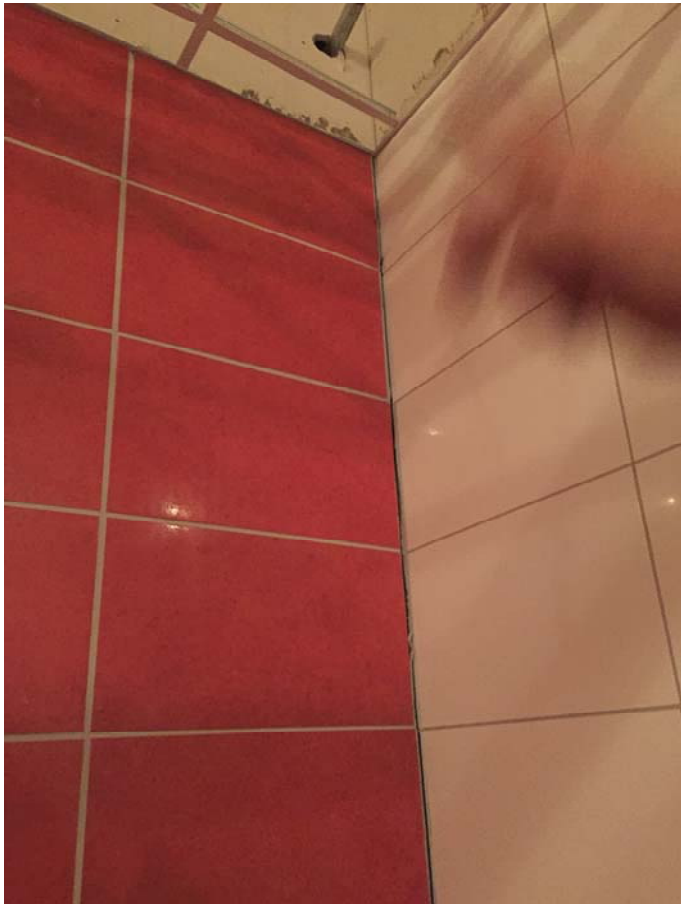
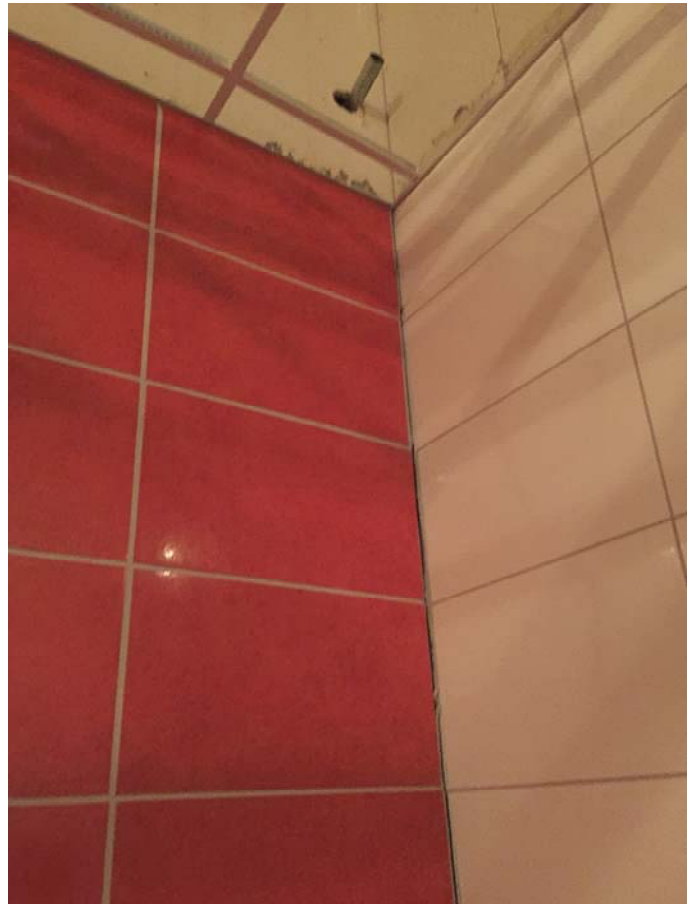
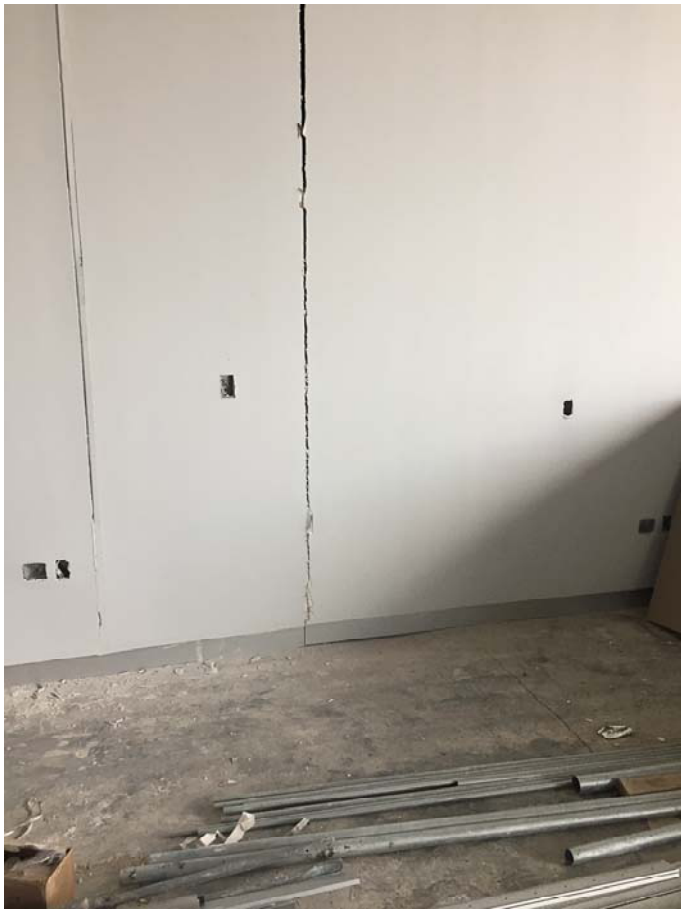
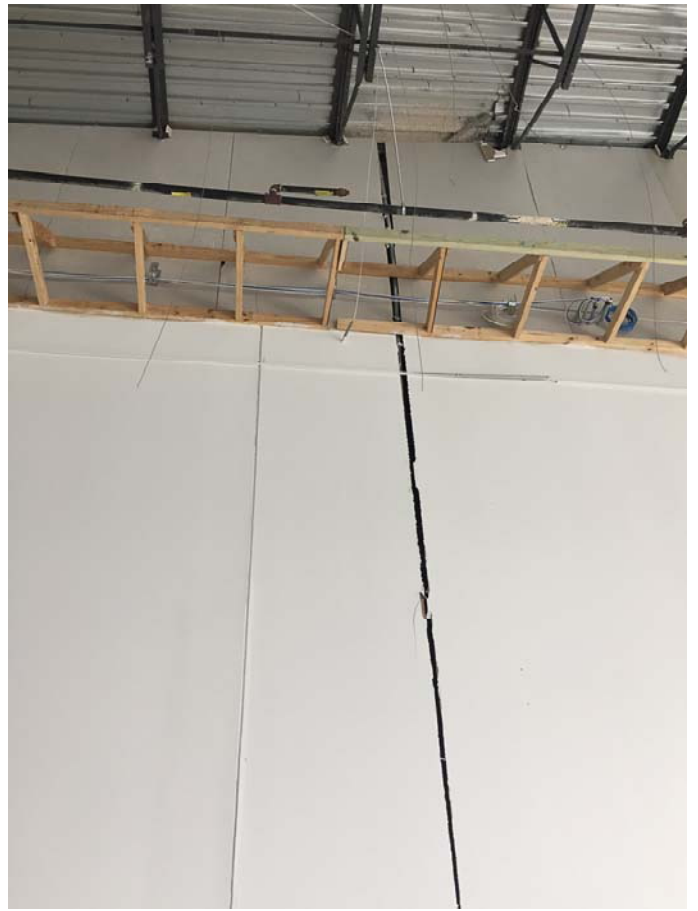
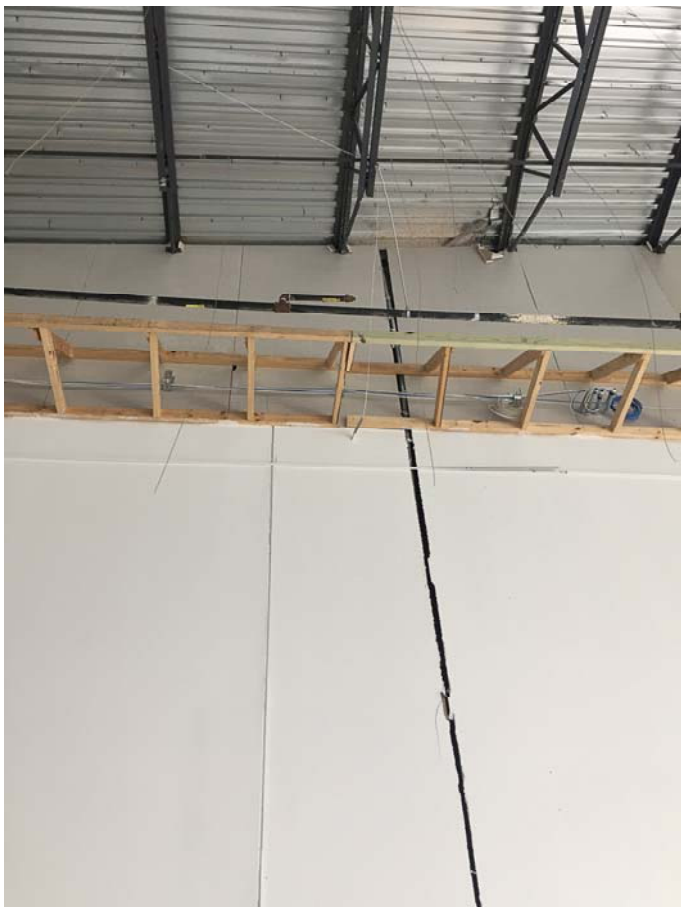
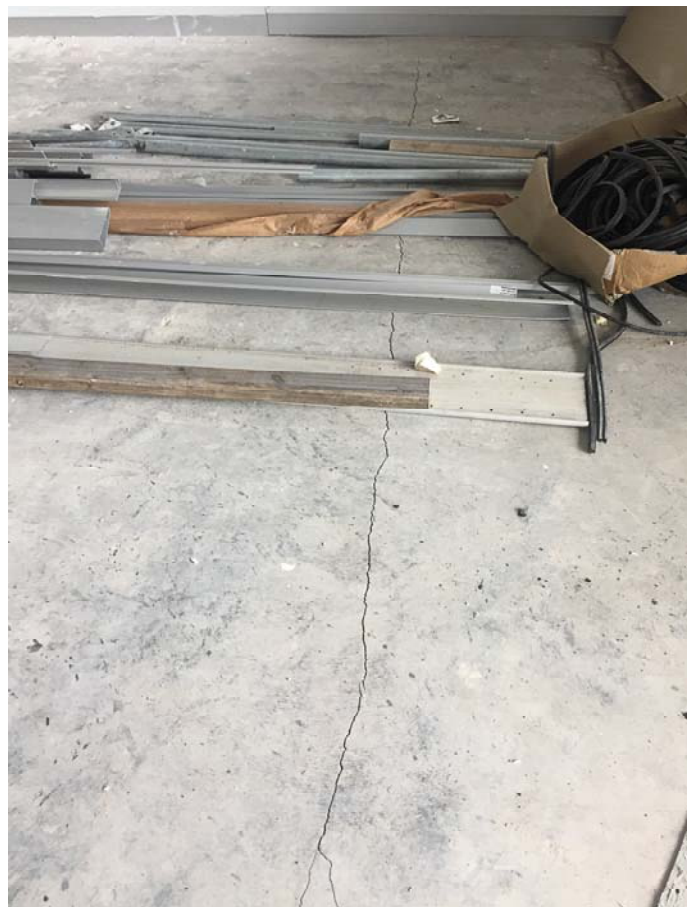
- There are two compromised structural connections at the library. On April 18th, 2018 these two connections broke. Our goal is to ensure that the building is 100% safe and structurally sound in every way.
- Measures are being taken today to "secure" these connections into place.
- We anticipate a full structural analysis. This analysis will contain more details as to the fix going on today, and any additional measures to be taken in the future.
- The contractor shall perform a slab survey to understand the result of any deflection in the all levels of the building. This information, coupled with the structural analysis will help us to determine the proper course of action.
